Manhole Inspection Summary

Manhole # S51M__008MH

Insp Date: **4/14/08 3:38 PM**

Location Address: **904 linwood curley**

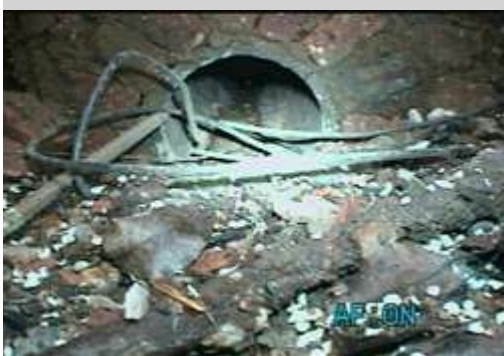
Defect 3

Condition: ☐ Sound ☐ Cracked ☐ Root Intrusion ☐ Deteriorated ☐ Leaks ☒ **Debris**

debris in channel

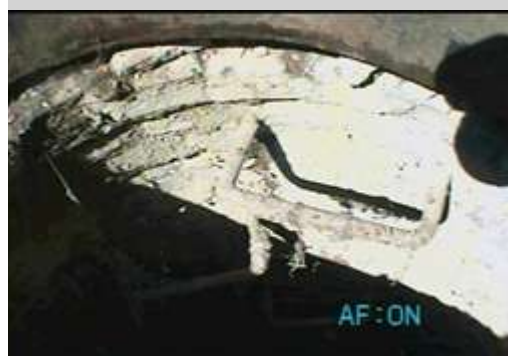
Defect 2

Steps Count: **4** Missing: **0** ☒ **Corroded**

corroded steps

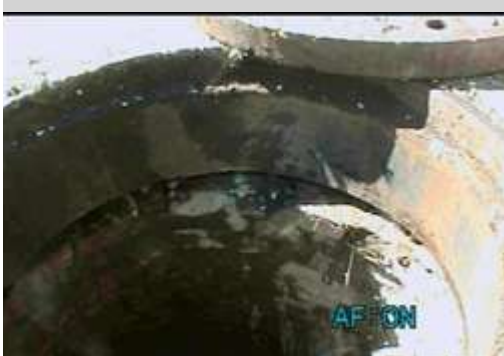
Defect 1

Condition: ☐ Sound ☐ Cracked ☐ Root Intrusion ☒ **Loose Brick** ☒ **Deteriorated**

Infiltration: ☐ None ☒ **Joint** ☐ Cracks ☐ Mortar ☐ Roots ☐ Wall

Condition: ☐ Sound ☐ Cracked ☐ Root Intrusion ☒ **Loose Brick** ☐ Deteriorated

Deteriorated Chimney, Chimney Infiltration, loose brick corbel

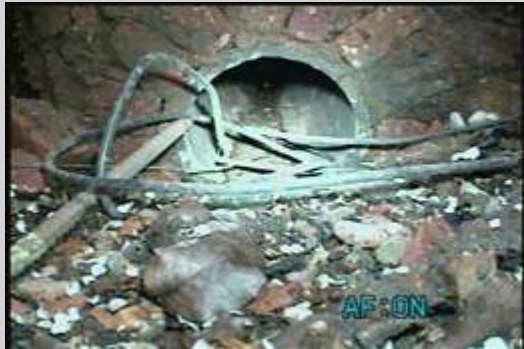
12 O'Clock Outflow

8 in. Circular Gravity Sewer
Pipe Out @ 12 O'Clock
